Manhole Inspection Summary

Manhole # S13W__004MH

Insp Date: **1/9/09 1:30 PM**

Location Address: **Wilso Dr.**

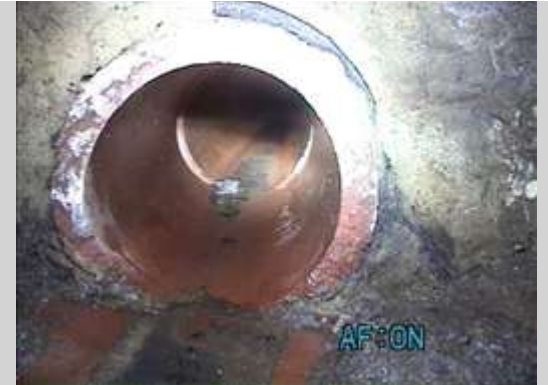
12 O'Clock Outflow

6 in. Circular Gravity Sewer
Pipe Out @ 12 O'Clock

Infiltration: **None** Pipe Seal Cond: **Sound**

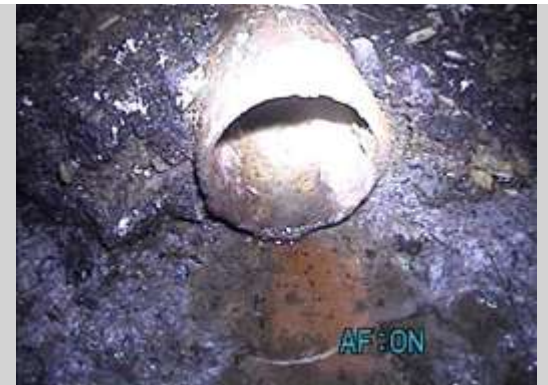
6 O'Clock Inflow

6 in. Circular Gravity Sewer
Pipe In @ 6 O'Clock

Infiltration: **None** Pipe Seal Cond: **Sound**
